**US Army Corps
of Engineers**

USACERL Technical Report 96/77
July 1996

Investigation of Preapproved Underground Heat Distribution Systems

by
Charles P. Marsh, Nicholas M. Demetroulis, and James V. Carnahan

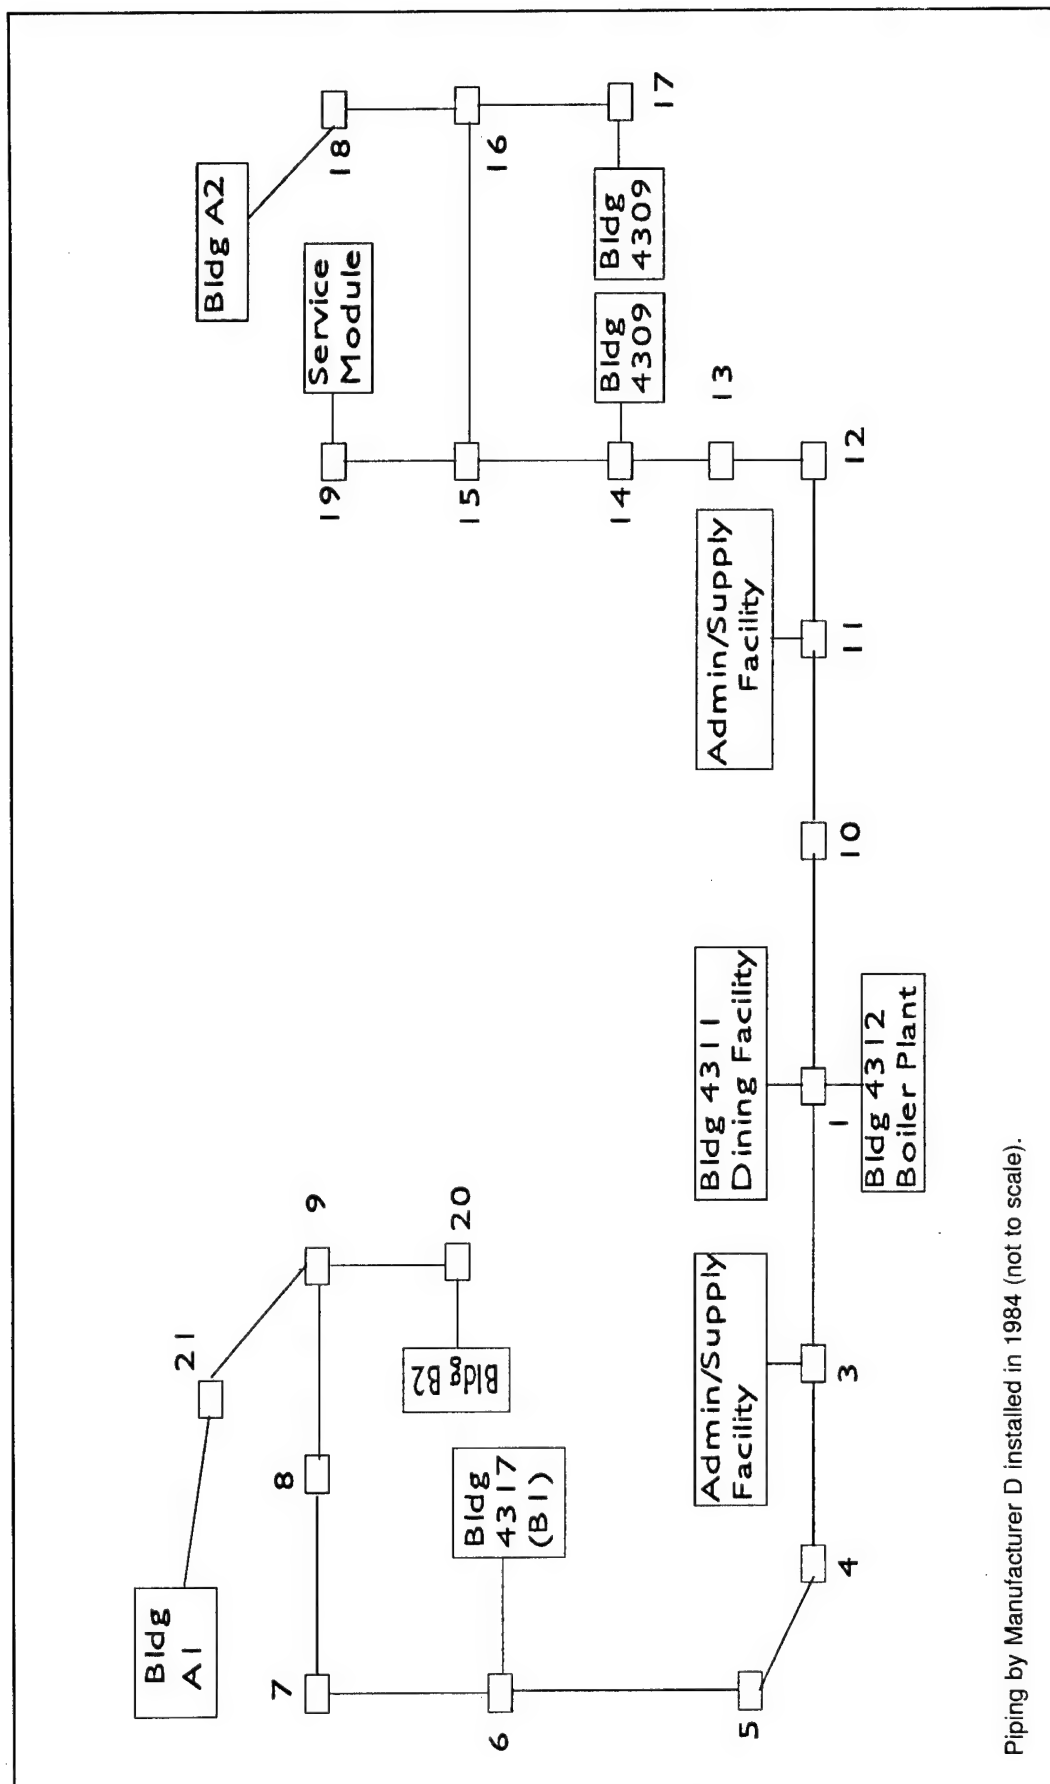
Figure C1. Schematic drawing of System 1 at Aberdeen Proving Grounds, MD.

f. Manhole 6—This manhole serves Building 4317. The sump pump was operational, and the manhole was dry. No steaming was observed at conduit vents. In this manhole, the steam supply and condensate return lines transition from

separate conduits to a single, common conduit that services Manhole 7. The access ladder is corroded and has a rung missing.

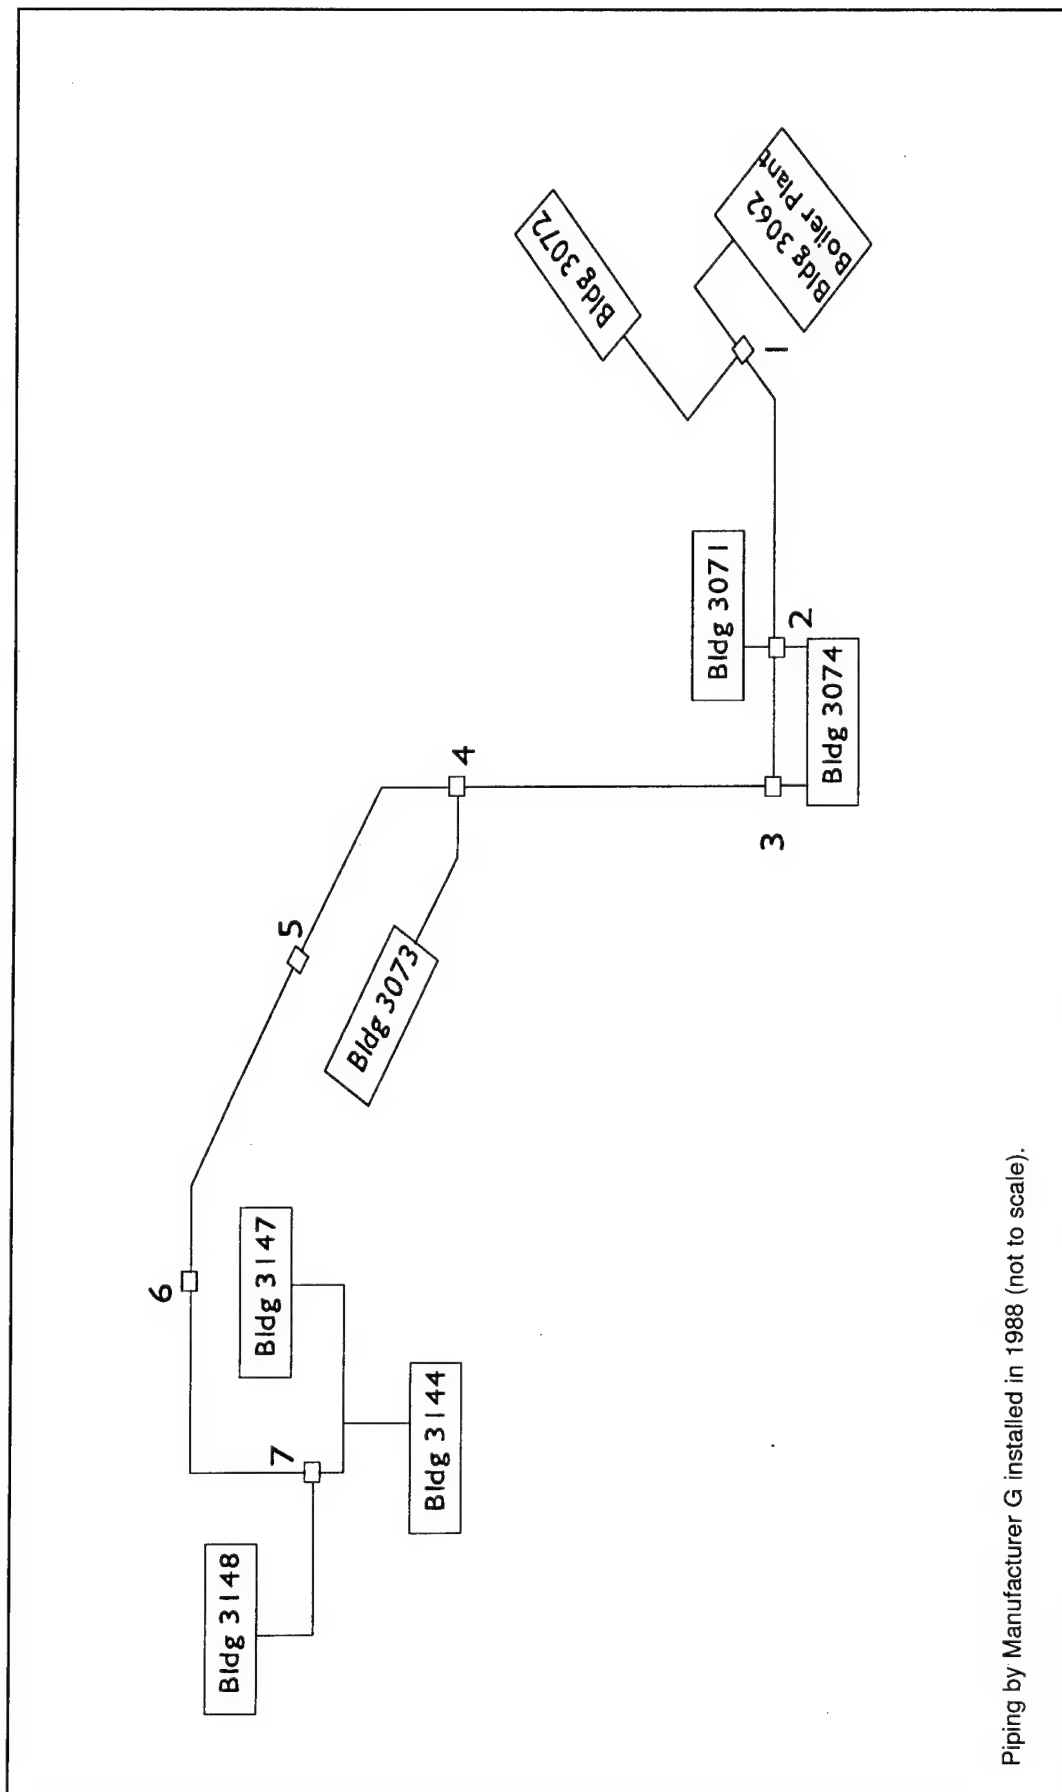
Figure C2. Schematic drawing of System 2 at Aberdeen Proving Grounds, MD.

This system consists of piping from Manufacturer G and has an FRP conduit (Figure C2). The project was "Replace Underground Steam and Condensate Piping From Boiler Plant (Bldg. 3062) to Bldgs. 3071, 3072, 3073, 3074, 3144, 3147 & 3148" (Drawing No. A38972) and was dated 1988.

a. Boiler Plant (Building 3062)—This boiler plant contains two oil-fired boilers, each rated at 12,552,000 Btu/hr. The operating steam pressure was 15 psi. No vents were installed on the conduits leaving the building.

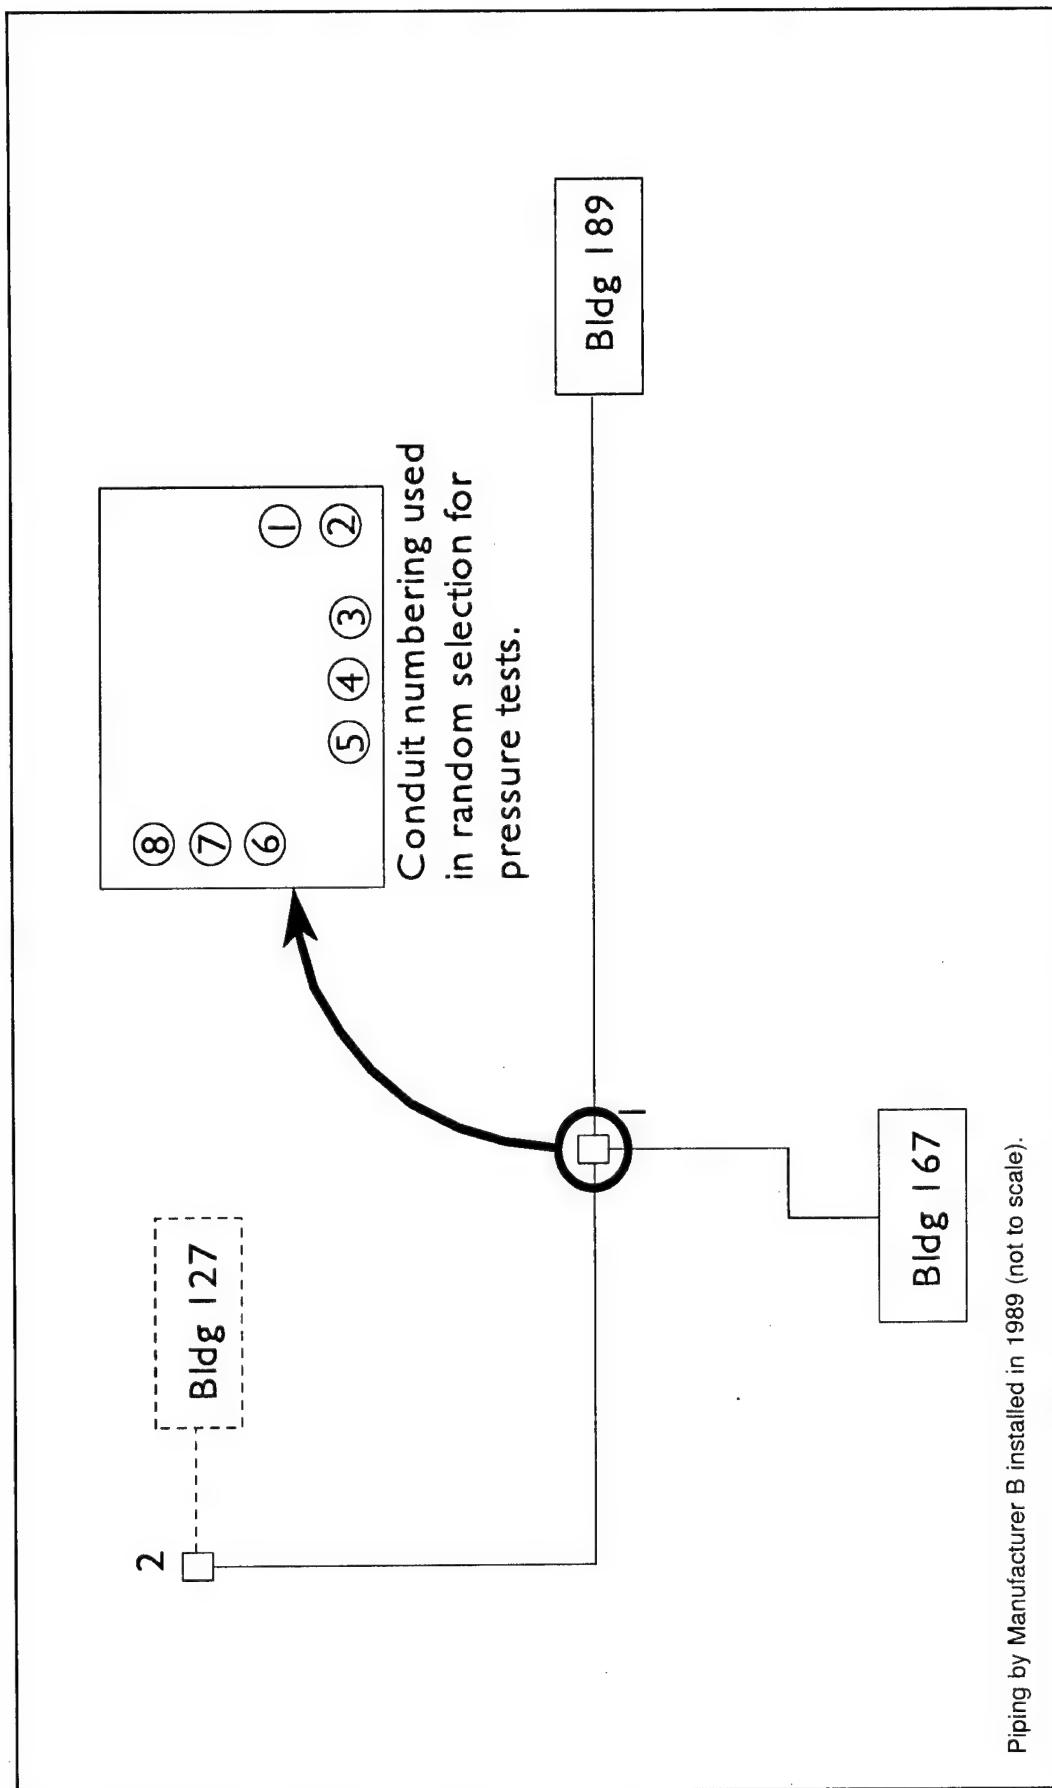
Figure D1. Schematic diagram of System 3 at Wright-Patterson AFB, OH.

a. Equipment Room - Building 189—Steam and condensate lines were contained in individual conduits. The steam conduit casing did not extend through the wall into

the equipment room as normally required. End plates appeared to be zinc coated and were in excellent condition. Vent and drain openings on both conduits were plugged.

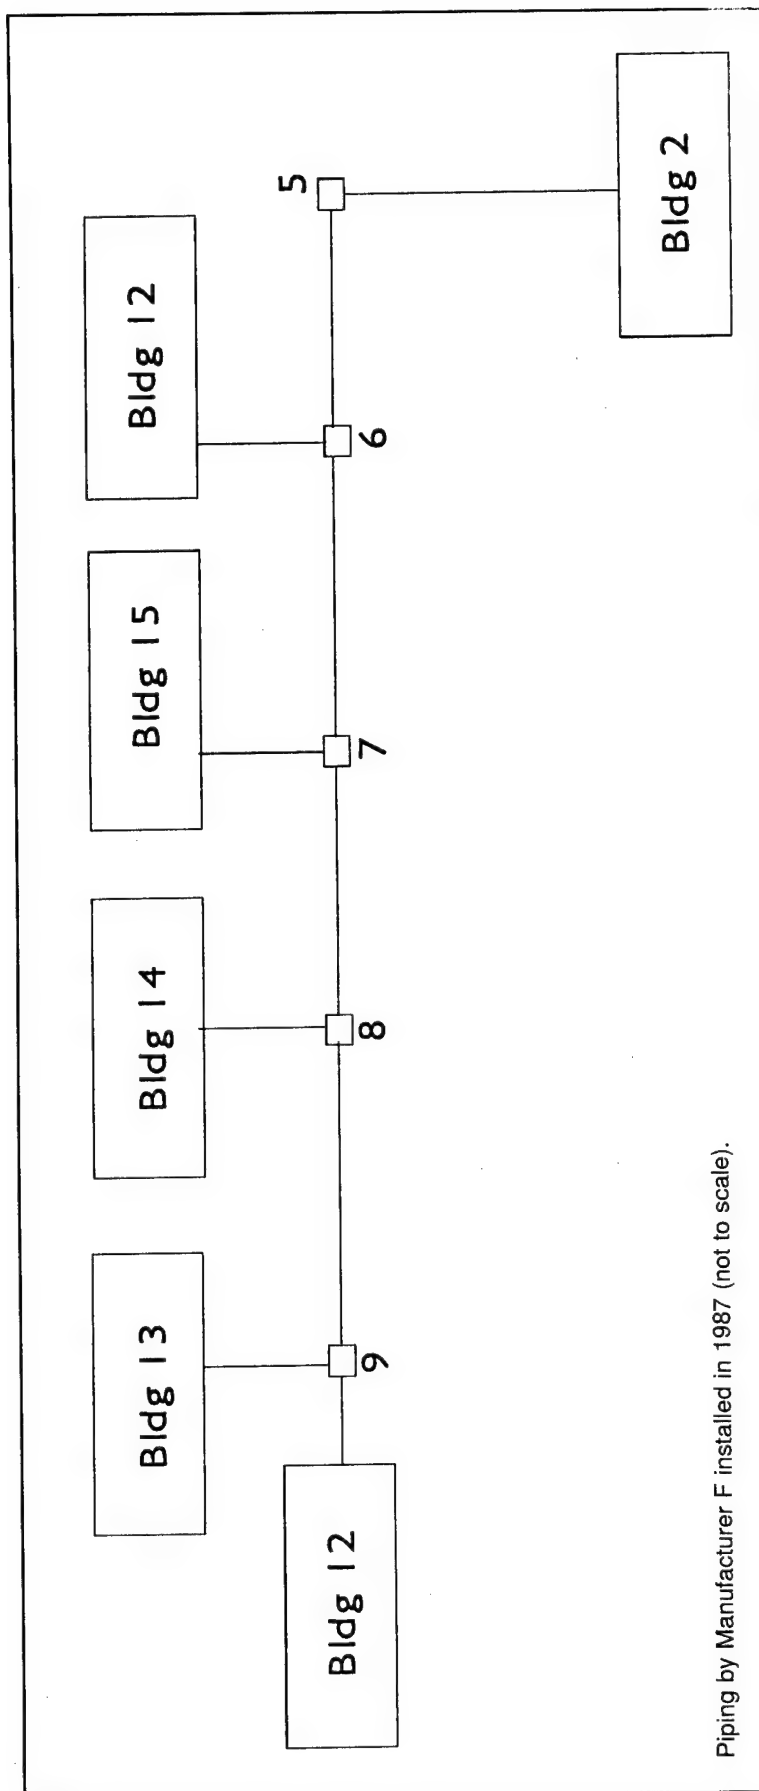
Figure E1. Schematic diagram of System 8 at VA-Bedford, MA.

a. Manhole 5—This manhole was round with a 6-ft diameter, was 9-ft deep, and was a solid concrete top design with a 30-in. manhole cover. No sump pump or means for ventilation were provided, and the manhole contained 3 in. of standing water. A

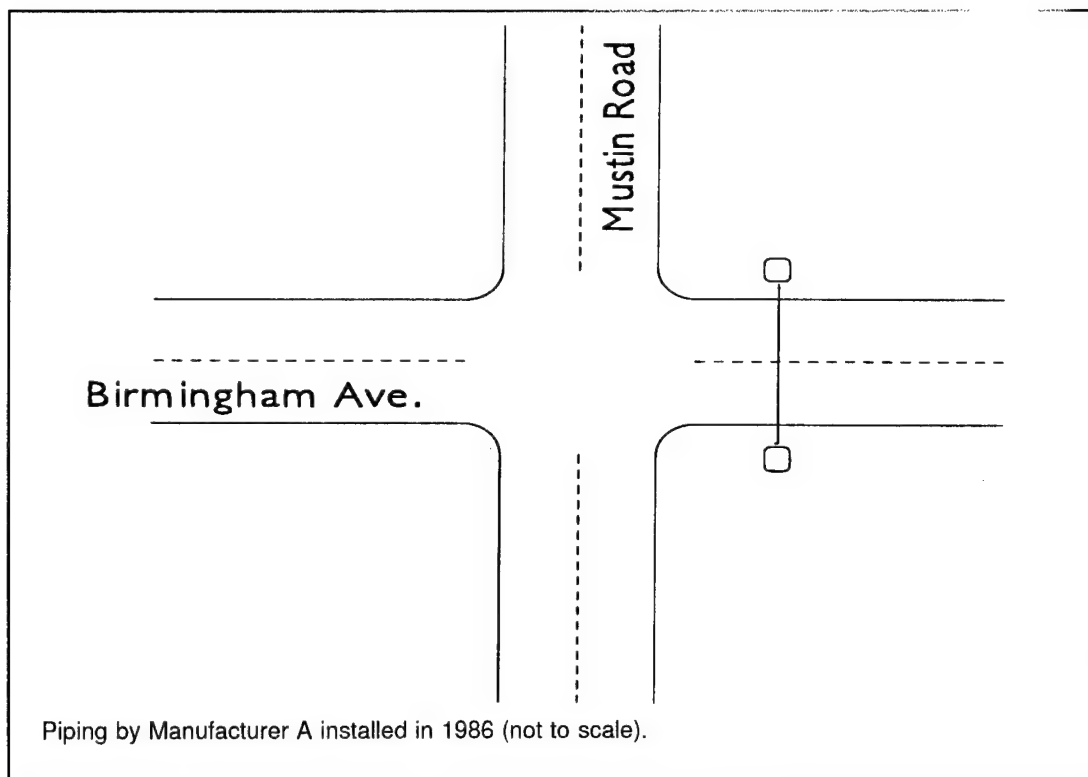
Figure I2. Schematic diagram of System 15 at Jacksonville NAS, FL.

This system consists of a single road crossing with piping from Manufacturer A and has a steel conduit (Figure I2). Installed in 1986, the project is under Birmingham Avenue near the intersection with Mustin Street. Risers on both sides of the street are fitted with loose water shed caps that precluded pressure testing.

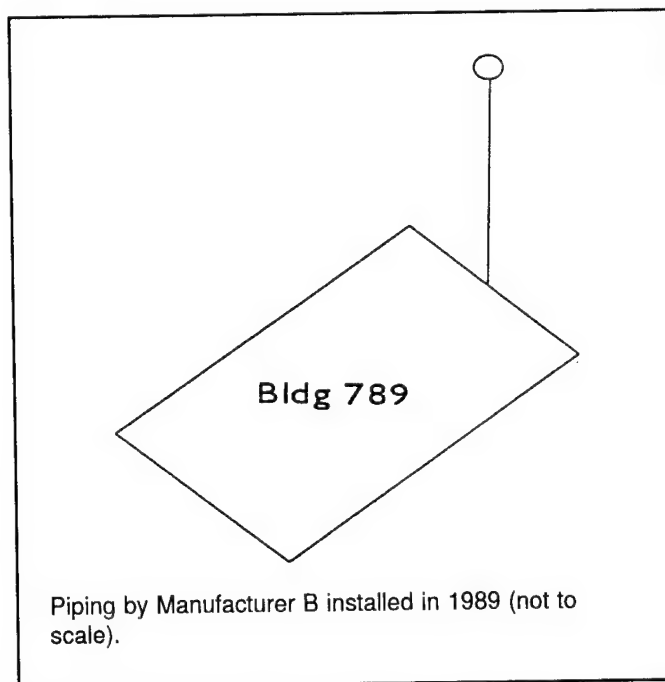
Figure I6. Schematic diagram of System 19 at Jacksonville NAS, FL.

This system consists of piping from Manufacturer B and has a steel conduit (Figure I6). It consists of a transition from above ground to below ground without a manhole. A single conduit containing both steam and condensate piping crosses Birmingham street and feeds Building 789. The riser had a loose water shed cap and the "Fostercoat" coating had some minor deterioration. The equipment room pit is 4 ft x 4 ft x 12 ft deep and has an electric sump pump. Gland seals were used at the end plates for both the steam and condensate piping. The single conduit drain was

plugged, but the vent was recessed into the pit wall and was full of concrete. The wall penetration was cemented and caulked, but slight water infiltration was noted. Some water seepage was also evident at an old wall penetration. A pressure test could not be performed because of the rain cap.

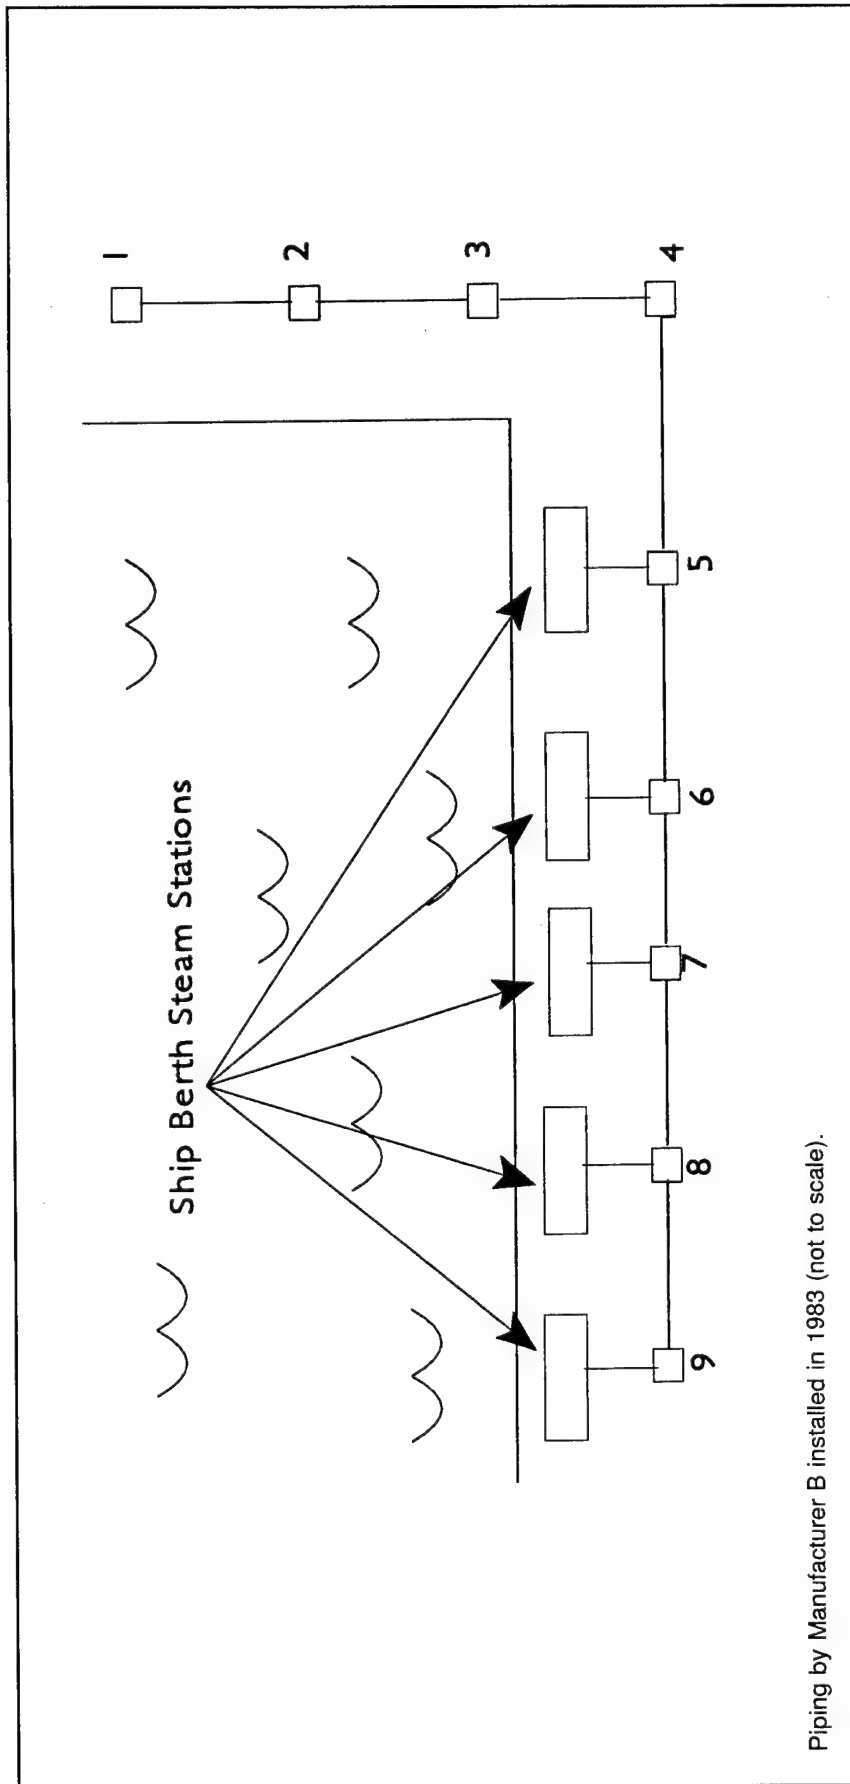
Figure J2. Schematic diagram of System 21 at Mayport Naval Station, FL.

Installed in 1983, this system consists of piping from Manufacturer B and has a steel conduit (Figure J2). A series of nine manholes serves a pier located about 800 ft north of Building 46. No condensate return piping was used. All manholes were of similar construction and design. The manholes were 6 ft × 6 ft × 10 ft deep, and most had one 6-in. manhole vent pipe. Each had solid concrete tops with 30-in.-diameter access with steel covers. No access ladders had been installed. Manhole wall penetrations were cemented and caulked. Gland seals were installed at the conduit end plates. The 8-in. steam line was contained in a 15-in. conduit. Light to very heavy steaming in all but the last manhole prevented entry for inspection. Steam escaping at a fitting was noted in Manhole 8. The last manhole at the end of the pier, Manhole 9, had no steaming but was still too hot to enter. A cathodic protection test station was found near the last manhole, but no dielectric flange connections had been installed.

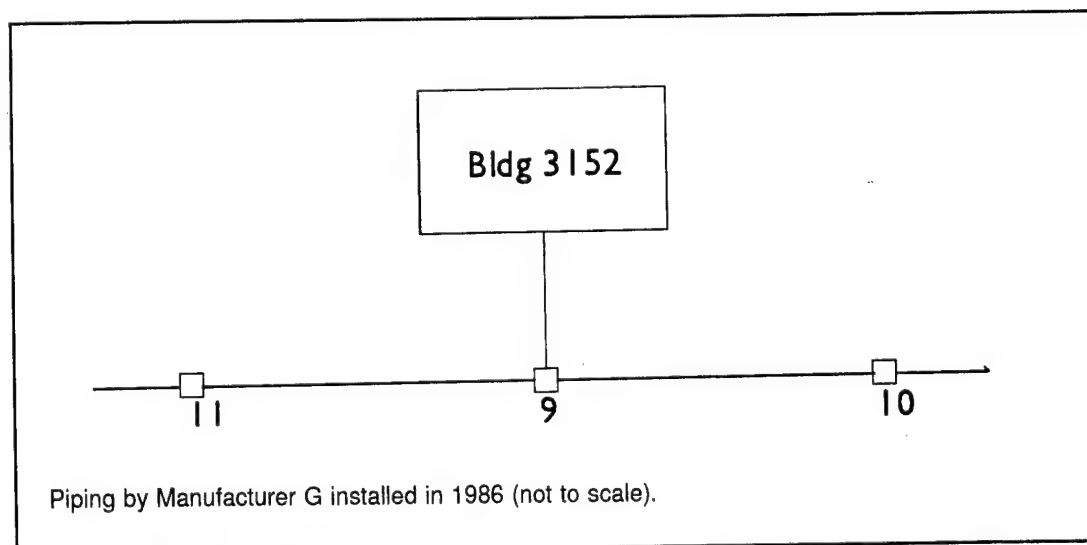
Figure O3. Schematic diagram of System 31 at Fort Lewis, WA.

Base personnel indicated that a major pipe leak was found in this system. The estimated cost for locating and repairing the leak was \$16,814 and the actual documented cost was \$14,234. However, it should be noted that the repair did not involve an "in-kind" replacement of the damaged system. Repair was accomplished by cutting out the failed section of conduit and installing a new carrier pipe covered with cellular glass insulation with a mastic coating. Cellular glass is not considered satisfactory for heat distribution system applications because of its brittleness, lack of shear strength, and its tendency to disintegrate under shock and vibration loads.
